# A HISTORICAL PERSPECTIVE OF ICE JAMS ON THE LOWER MOHAWK RIVER

**John I. Garver**  
**Jaclyn M.H. Cockburn**

Geology Department  
Union College  
Schenectady NY 12308

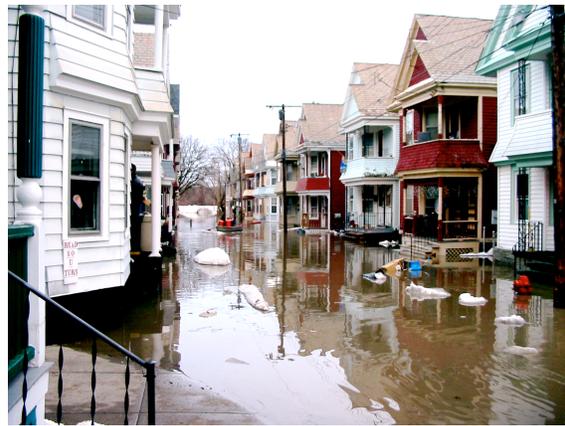
Figure 3: Flooding in the Stockade that resulted from the 2007 Ice jam on the lower Mohawk River. Picture taken in the late afternoon (~18:00) at nearly peak stage elevation. Peak discharge during this event was c. 50k cfs, but ice jamming resulted in back up of water that caused flooding (Photo: J.I. Garver).

**The 15 March 2007** flooding in the Stockade was entirely related to ice jamming downstream from the city of Schenectady (Figure 3). During this event, discharge in the Schenectady reach of the Mohawk River never surpassed 45 to 50 k cfs, which makes this an insignificant event with respect to expected high water. However, the formation of the ice jam and the resulting backup of water was entirely responsible for the inundation that occurred in the Stockade. This reinforces earlier findings that the key component in these events is the evolution of stage elevation, which is not directly related to discharge. Back up of water behind the 15 March 2007 ice jam resulted in a ~13 feet elevation change. Breakage of the ice dam at about 6:45 PM resulted in a downstream rush of water referred to as an ice jam release wave that was recorded at the USGS station at Cohoes. Peak discharge at Cohoes occurred at 8:00 PM and then total discharge was 51.6 k cfs. It is possible that that was an ice jam release wave, but the measurements are too coarse (every 15 minutes) to determine this with certainty.
