MOHAWK WATERSHED SYMPOSIUM

2012

ABSTRACTS AND PROGRAM

**COLLEGE PARK HALL
UNION COLLEGE
SCHENECTADY NY
16 MARCH 2012**

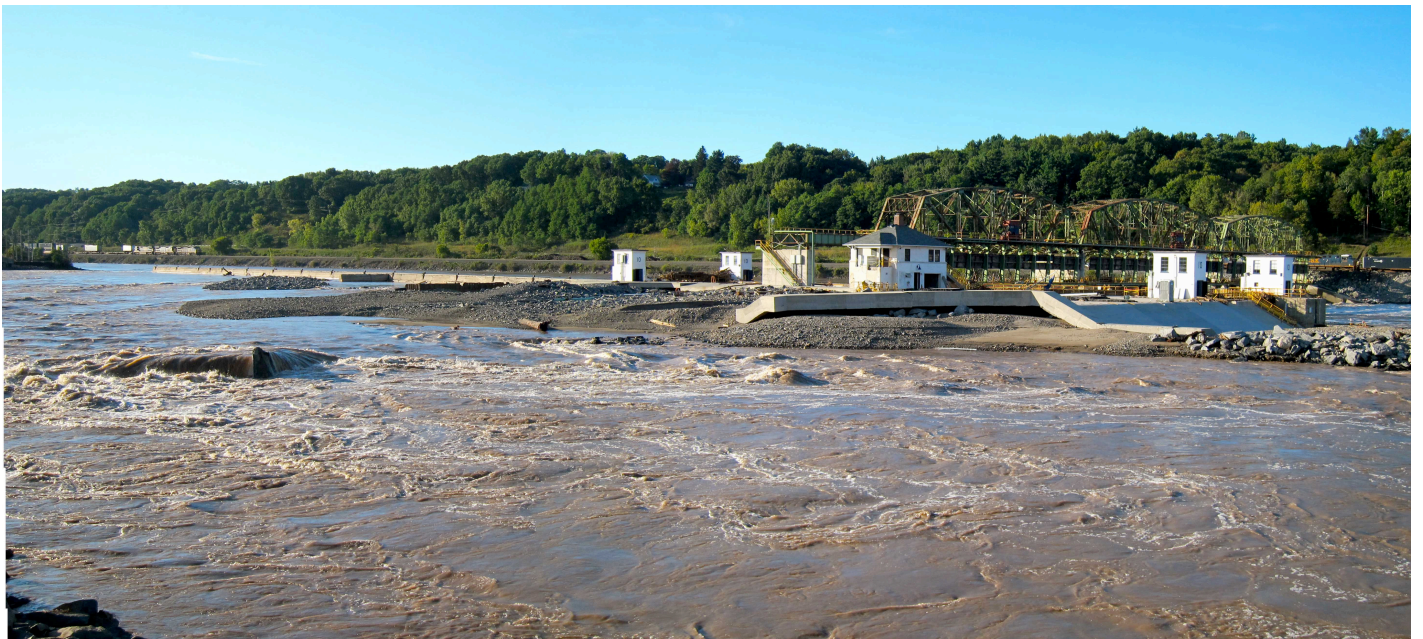
On the cover: Lock 10, Cranesville (NY) after breach that occurred during flooding related to the remnants of Tropical storm Lee, 10 September 2011. Locks 8, 9, and 10 had similar failure during the floodwaters related to flooding first initiated by rain and flooding associated with Hurricane Irene and then Tropical storm Lee. Lock 10 is notable because the River flowed around the lock structure in 2006 and extensive repairs were required after that event – the new structures and spillway can be seen in the middle ground of the photo. Photo: J.I. Garver, Geology Department, Union College.

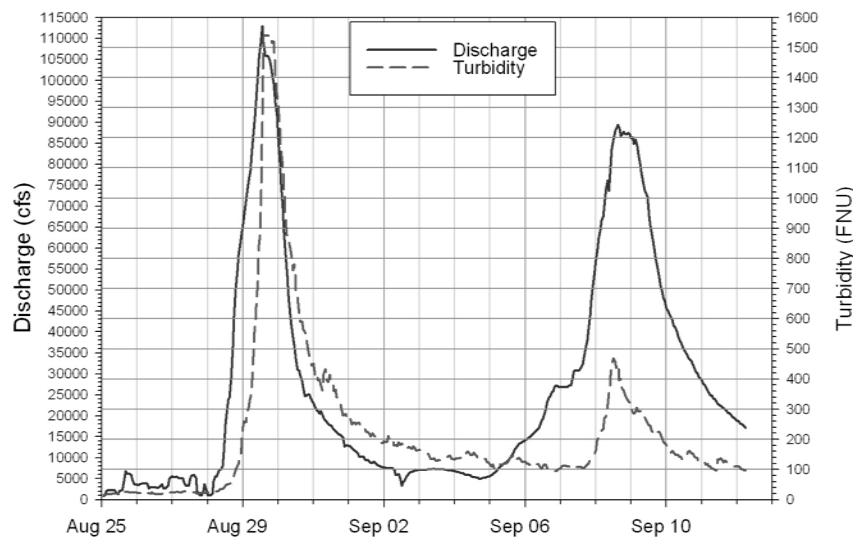
Figure 1: Hourly discharge and turbidity measured on the Mohawk River at Cohoes, NY during Irene and Lee in late summer 2011 (data from USGS).

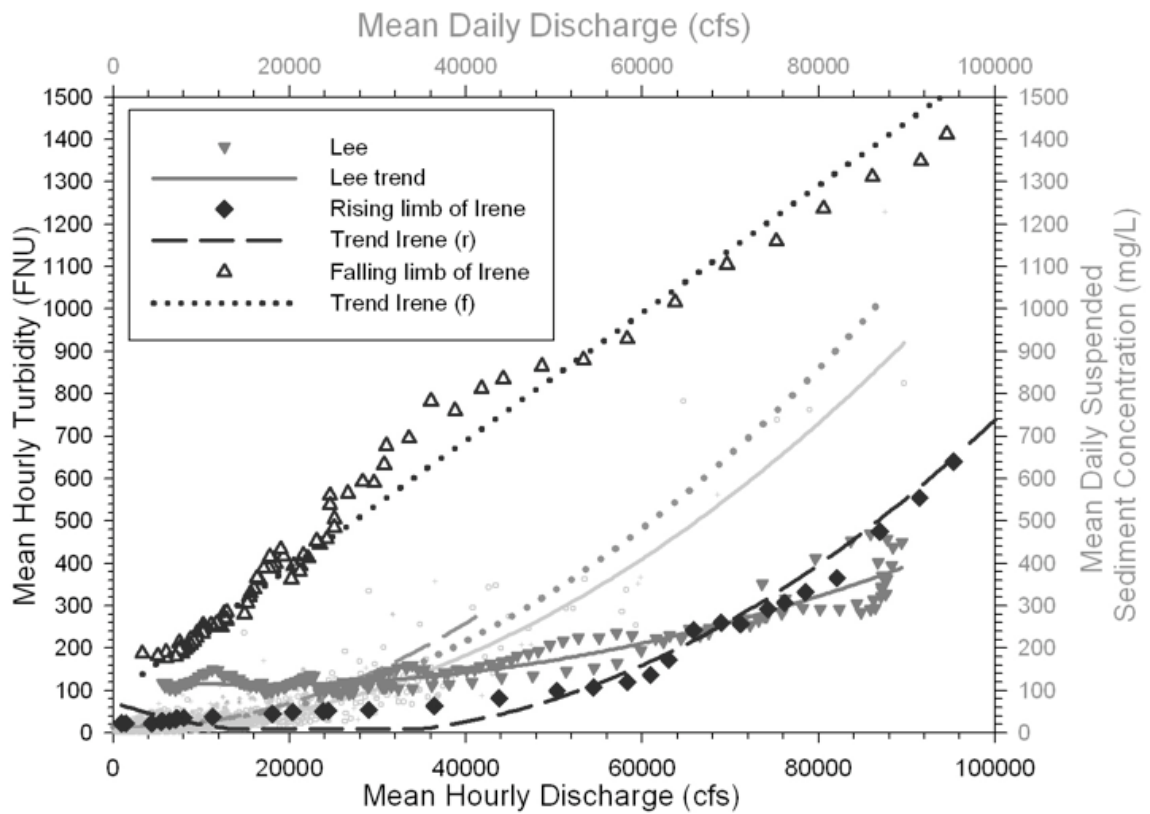
Figure 2: Mean hourly discharge and turbidity in the Mohawk River measured at Cohoes, NY during Irene and Lee. Light gray (background) points represent the daily values over the periods between 1954-57 and 2004-07.

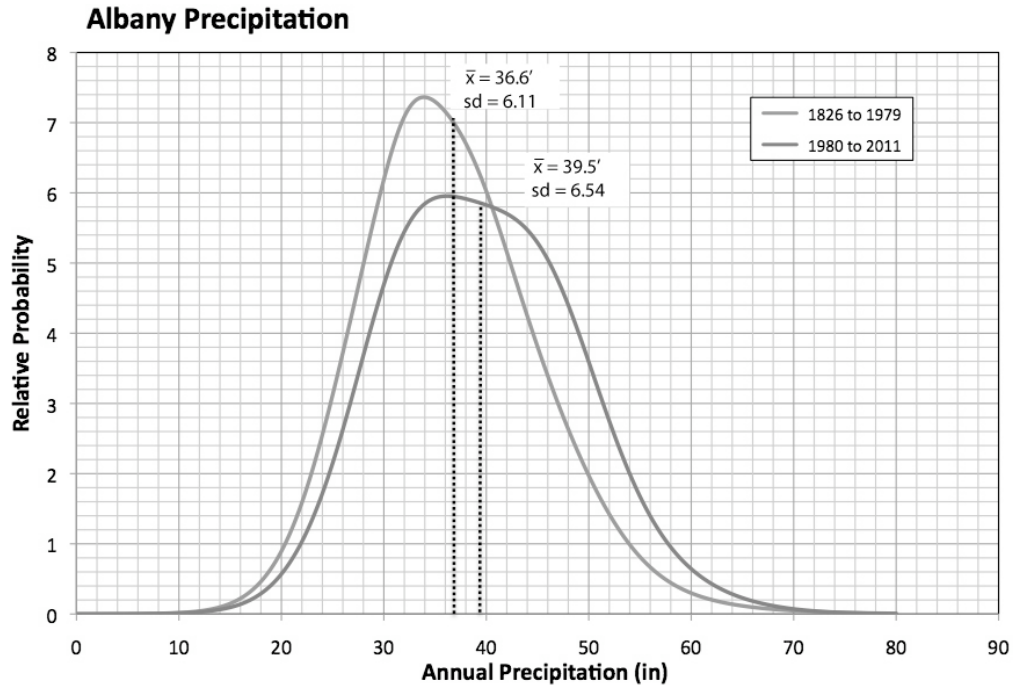
FIGURE 4: Change in precipitation in Albany (NY) over the entire record (1829 to 2011). Here we plot annual events summed as a probability density function for 1826 to 1979 and 1980 to 2011. One of the basic tenants of evaluation of regional change is to measure and understand subtle (or not subtle) changes in the geometric mean, and overall distribution of a number of key climate parameters. This analysis shows an increase in annual precipitation in the last several decades (data: NOAA/NWS data collected for Albany NY; estimation kernel for probability density of four).

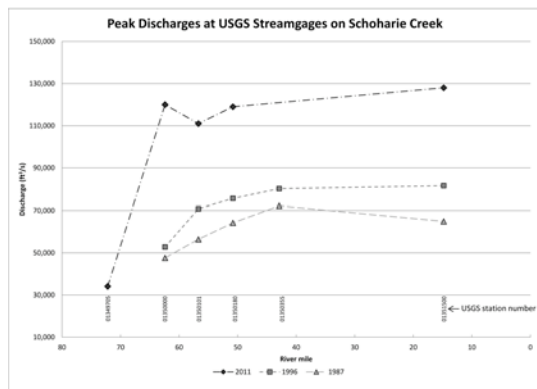
Figure 1: Peak discharges at U.S. Geological Survey streamgages on Schoharie Creek during floods of 1987, 1996 and 2011.

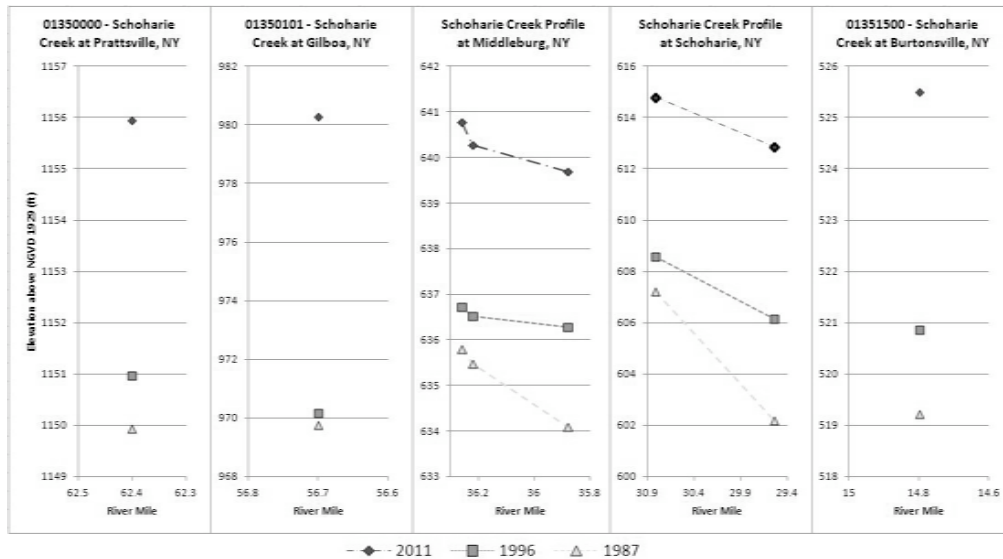
Figure 2: High-water mark elevations surveyed at selected U.S. Geological Survey streamgages and communities on Schoharie Creek following floods of 1987, 1996 and 2011.

Following the storm, field crews surveyed high-water marks on streambanks, trees, structures and anywhere a distinct high-water mark elevation could be documented. This effort recovered data from USGS streamgages that did not record the peak gage heights and discharges due to damages from the storm. These surveys revealed that the Schoharie Creek changed its usual course in many locations, bypassing or submerging bridges and levees often relied upon to contain floodwaters. Seventeen indirect measurements were made to compute peak flows and extend stage-discharge rating curves at gages where previous rating curves were exceeded by the unprecedented flooding. Also, along the Schoharie Creek, nearly 200 high-water marks were surveyed to provide essential information to FEMA and other emergency response agencies working to rebuild communities affected by the flooding. This data was also useful in creating a flood profile to document the extent of flooding resultant from tropical storm Irene, and compare it to flood profile surveys on the Schoharie Creek following the 1987 and 1996 floods.

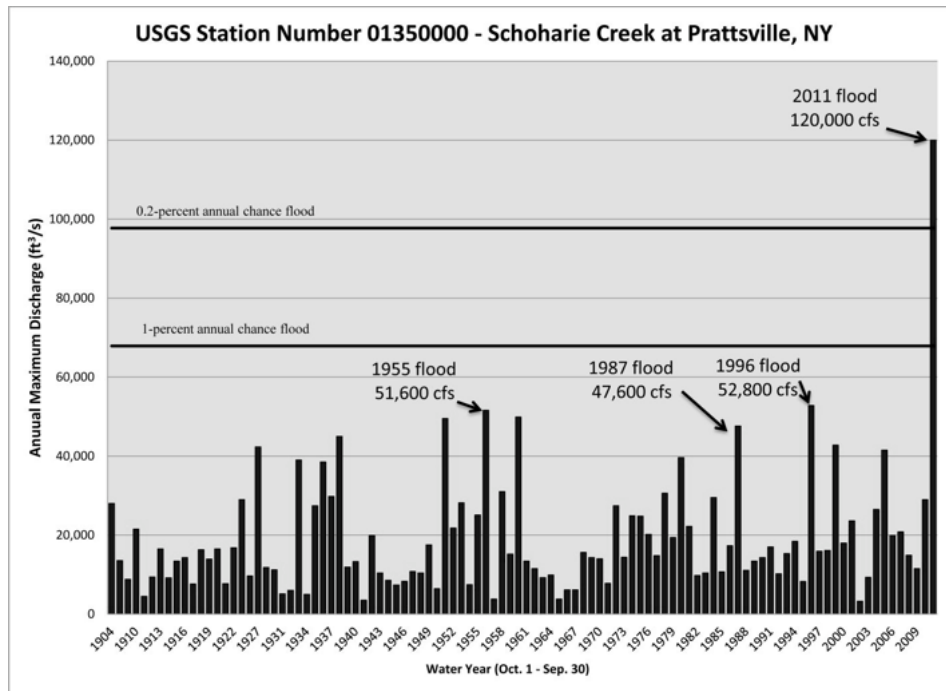
Figure 3: Annual peak discharges for the period-of-record at USGS station number 01350000 – Schoharie Creek at Prattsville, NY (0.2 and 1-percent annual chance of flood discharges from FEMA, 2008).

was the Schoharie Creek at Prattsville, NY (01350000) station, where peak flows have been recorded since 1902, and had a peak discharge of 120,000 ft³/s. This is more than double the previous peak recorded during the January 1996 flood (figure 3). The extreme flows at Prattsville, NY reflect the large peak discharges per unit area observed at USGS stations in the headwater tributaries; such as Batavia Kill at Red Falls near Prattsville, NY (table 1.) The confluence of the main stem of Schoharie Creek and Batavia Kill occurs about 0.81 miles upstream from Prattsville, NY.

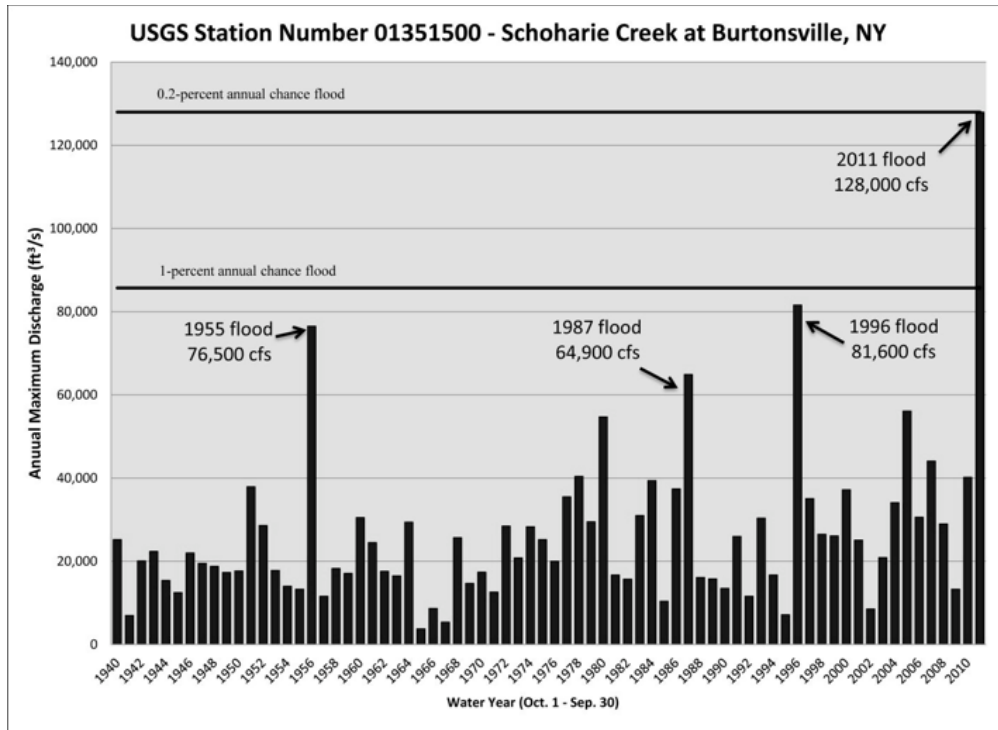
Figure 4: Annual peak discharges for the period-of-record at USGS station number 01351500 – Schoharie Creek at Burtonsville, NY (0.2 and 1-percent annual chance of flood discharges from FEMA, 2012).

The most downstream USGS streamgauge on the Schoharie Creek is at Burtonsville, NY (01351500). The peak flow at this station exceeded the previous period-of-record maximum, recorded in 1996, by over fifty percent (figure 4). Although the flooding was significant in Burtonsville and to the mouth of the Schoharie Creek at the Mohawk River, the peak discharge per unit area was less than half of any other USGS streamgauge in the Schoharie Creek basin. This exemplifies the high degree of flooding generated in the higher elevations, where total discharge was less, but peak run off was over five times as great in some streams (table 1). When the Schoharie Creek entered the Mohawk River near Fort Hunter, NY, it contributed to serious flooding in communities downstream. The Mohawk River at Cohoes, NY (01358000) streamgauge experienced a 3.3-percent annual chance flood, much less extreme than anything experienced in the Schoharie Creek, primarily because of less intense rainfall in the upper Mohawk River, East Canada Creek and West Canada Creek basins.

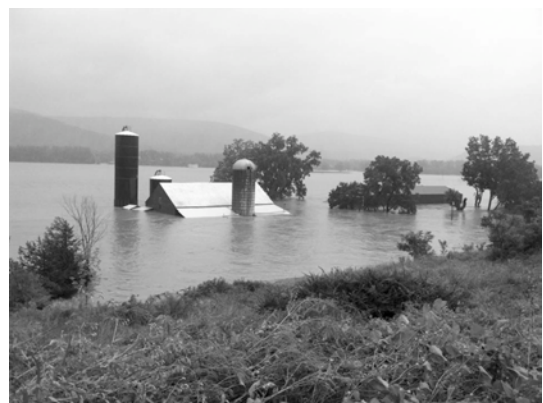
A southeast view of Schoharie Ck at Pindar Flats in Middleburgh

On August 25th 2011 the National Weather Service tracked Irene as a Category Three Hurricane moving Northwest at 12 mph. Predictions circulating around Schoharie County anticipated the storm making landfall at New York City and tracking East. The amounts of rainfall that fell on the Catskill Mountains and areas of Schoharie County were unexpected, and resulted in historic flooding in the Schoharie Valley. On August 28th 2011, flood evacuation sirens sounded throughout the Schoharie Valley before the main stem of the Schoharie Creek experienced 500-year flood flow elevations causing widespread damage. Feeder tributaries into the Schoharie Creek experienced severe bank erosion as well as backwater resulting in aggradation of sediment and woody debris jams at all the confluences. Bridges, cross culverts, and roadways were undermined causing several millions of dollars in damage. An estimated 1000 homes and business either experienced flood damage or were destroyed completely. Emergency operations were evacuated from their headquarters in Schoharie, and again from their temporary Emergency Operations Center (EOC) in Cobleskill when Tropical Storm Lee struck eleven days later. Lee spared the eastern parts of the county including the Schoharie Creek Watershed communities, but resulted in historic localized flooding in the western half of the county. Thus began a multiple agency recovery effort involving FEMA, SEMO, Army National Guard, Army Corps of Engineers, NYSDEC, NYSDOT, Schoharie County Public Works, Emergency Management, Sheriff's Dept., local highway dept.'s, and Schoharie County Soil and Water working collaboratively to begin an unprecedented recovery effort to protect public health and safety. Stream work during a thirty day Emergency Permit Authorization issued by NYSDEC allowed streams to be cleared of excess gravel and woody debris in an effort to protect key infrastructure, and multiple residences. Six months later, there still remains a need to evaluate stream conditions county wide to assess where needs still exist for providing long term solutions to stream stability. Using Natural Channel Design principles, assessment and subsequent restoration of streams by environmental agencies will likely continue for the next several years. Discussion of ways to mitigate future flood damage including aggressive floodplain management has begun at the county level. Local agencies are constantly seeking funding to support flood mitigation, education and outreach efforts, and acquisition for at risk properties. Some stream assessments have begun in an effort to gauge how these waterways will react to future high water events due to changes in their physical conditions (i.e. profile, slopes) as a result of the floods. Ecological assessments of several first and second order streams will begin in the spring of 2012 by SUNY Cobleskill Fish and Wildlife Department and Chemistry students and staff. Using historical data collected at specific reaches; teams will assess any significant changes that may have occurred in these locations regarding physical/chemical water quality, macro-invertebrate EPT indexes, fish populations, and stream gradient. This data will assist environmental agencies in determining flood effects on the overall bio-diversity of these waters throughout the county. Concise survey data such as this will help local agencies ascertain whether or not future mitigation work on these streams will be necessary. Discussions have also begun for developing strategies to restore stream banks that have been denuded of important soil stabilizing riparian vegetation. Areas to focus on would be key flood prone locations along the Schoharie Creek main stem, and several feeder tributaries. Volunteer planting projects designed to address this have already started to materialize, and restoration efforts will be ongoing for several years.

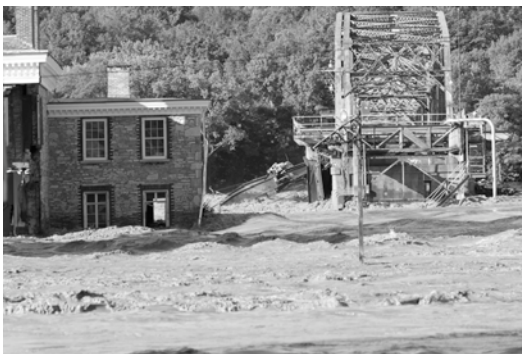
Figure 1. Hurricane Irene floodwaters impact Lock E-11 and Guy Park Manor in Amsterdam.

Hurricane Irene resulted in substantial rain throughout the eastern Mohawk Valley between August 28 and August 30, 2011. The heaviest rainfall occurred in the headwaters of the Schoharie Creek watershed, where over 12 inches of rain were measured in a twelve-hour timeframe in Tannersville, NY. Schoharie Creek flows exceeded the largest rates ever recorded prior to this event by approximately 50 percent. These record flows resulted in widespread flooding along the Erie Canal/Mohawk River downstream of the confluence of the Schoharie Creek and the Erie Canal in Fort Hunter. In fact, record flood levels since the Erie Canal was constructed in 1915 were observed at Lock E-7 (Vischer Ferry), Lock E-9 (Rotterdam Junction), Lock E-10 (Cranesville), Lock E-11 (Amsterdam), and Lock E-12 (Tribes Hill). Observed flood levels at each of these navigation locks, associated with the record flow rates and the accumulation of substantial debris at the movable dams adjacent to the navigation locks exceeded record levels by many feet. The forces associated with the record flooding and accumulated debris resulted in significant structural damage to both the movable dams and the associated canal facilities. Guy Park Manor, a Georgian house built in 1773 at Lock E-11 (Amsterdam) was severely damaged by the floodwaters (Figure 1).

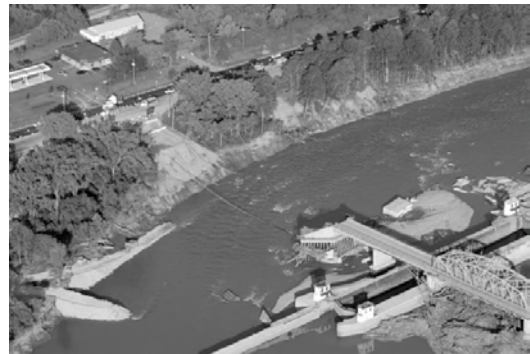
Figure 2. New York State Route 103, adjacent to Lock E-9 in Rotterdam Junction, was washed away following Hurricane Lee.

Just as Canal Corporation staff were conducting damage assessments and developing plans for the reopening of the Erie Canal, the remnants of Hurricane Lee wrung out another round of heavy rain throughout the Mohawk Valley, between September 7 and September 9, 2011. Substantial flooding resulted at the same locations that were just flooded by Hurricane Irene. The saturated lands adjacent to Lock E-8 (Scotia), Lock E-9 (Rotterdam Junction), and Lock E-10 (Cranesville) were washed away. At these locations, water flowed around the debris-choked movable dams and carved new deep channels around each lock resulting in widespread damage. This washed away historic powerhouses and the eroded sediment was deposited in the canal channel. Significant damage occurred at Lock E-9 (Rotterdam Junction) where the northern portion of New York State Route 103 was completely washed away (Figure 2).

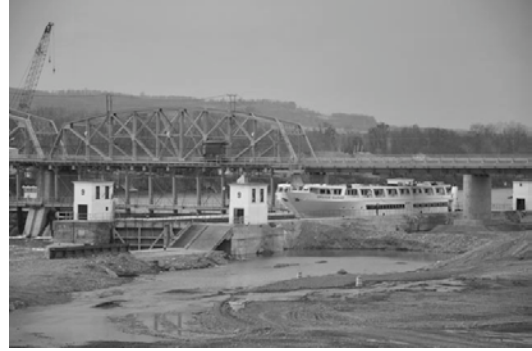
Figure 3. The cruise ship Grande Mariner navigates through the re-opened Erie Canal at Lock E-9, Rotterdam Junction as repair efforts continue.

The re-opening of the Erie Canal on November 20, 2011 (Figure 3), following the catastrophic damage associated with Hurricanes Irene and Lee was a testimony to the spirit and determination of the entire Canal Corporation's staff. Structural steel repairs to the movable dams, dredging of the navigation channel, debris removal, and a myriad of other repairs were made in order to facilitate this re-opening. Considerable work remains to complete the repairs and return the damaged areas to their pre-storm condition. The Canal Corporation remains committed to completing these repairs and to the on schedule opening of the Erie Canal on May 1, 2012, marking the 188th consecutive navigation season, weather and water level permitting.
